Contract #: 04-0120F4Cty: SF/ALA Rte: 80 PM: 13.2/13.9File #: 69.28**WELDING INSPECTION REPORT****Resident Engineer:**Pursell, Gary**Address:** 333 Burma Road**City:** Oakland, CA 94607**Report No:** WIR-001746**Date Inspected:** 07-Mar-2008**Project Name:** SAS Superstructure**OSM Arrival Time:** 700**Prime Contractor:** American Bridge/Fluor Enterprises, a JV**OSM Departure Time:** 1700**Contractor:** Zhenhua Port Machinery Company, Ltd (ZPMC), Changxing Island **Location:** Shanghai, China**CWI Name:** Xu Le Feng, Ye Yong Jun**CWI Present:** Yes No**Inspected CWI report:** Yes No N/A**Rod Oven in Use:** Yes No N/A**Electrode to specification:** Yes No N/A**Weld Procedures Followed:** Yes No N/A**Qualified Welders:** Yes No N/A**Verified Joint Fit-up:** Yes No N/A**Approved Drawings:** Yes No N/A**Approved WPS:** Yes No N/A**Delayed / Cancelled:** Yes No N/A**Bridge No:** 34-0006**Component:** Tower Mock-ups and OBG**Summary of Items Observed:**

Macro Etch Samples

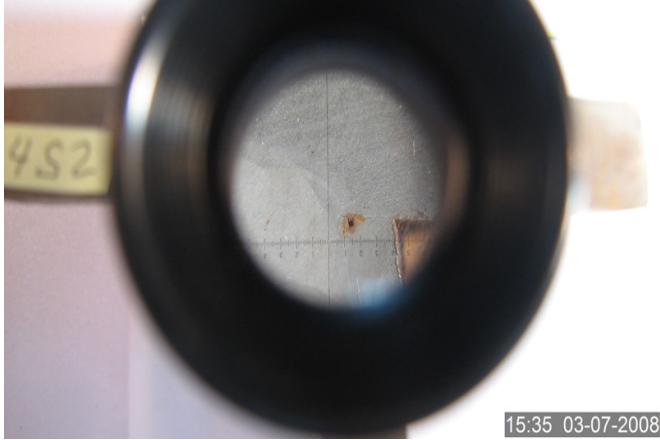
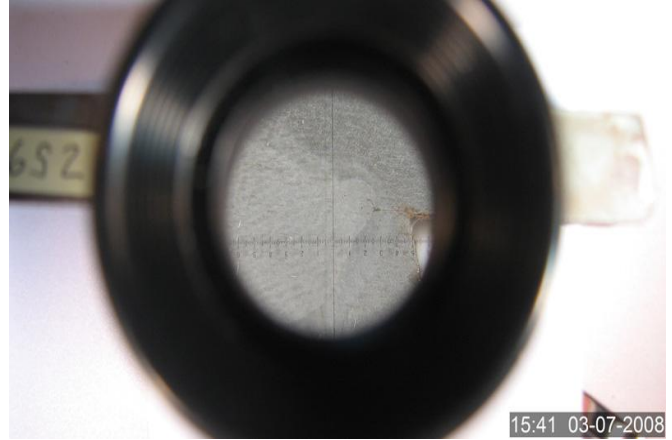
The Quality Assurance Inspector reviewed the macro etch samples for three production monitoring tests for corresponding deck panels DP-057-001 and DP-059-001. In addition the Quality Assurance Inspector reexamined five samples that were returned to ABF with the recommendation for re-etching. In total the Quality Assurance Inspector examined forty samples. The Quality Assurance Inspector recorded the measurements in an onsite log for future review. The Quality Assurance Inspector observed several anomalies and photographed the samples. Below are two digital photographs of anomalies observed on this date.
